INDOOR AIR QUALITY ASSESSMENT

**Shutesbury Town Hall
1 Cooleyville Road
Shutesbury, Massachusetts**

Prepared by:
Massachusetts Department of Public Health
Center for Environmental Health
Emergency Response/Indoor Air Quality Program
August 2005

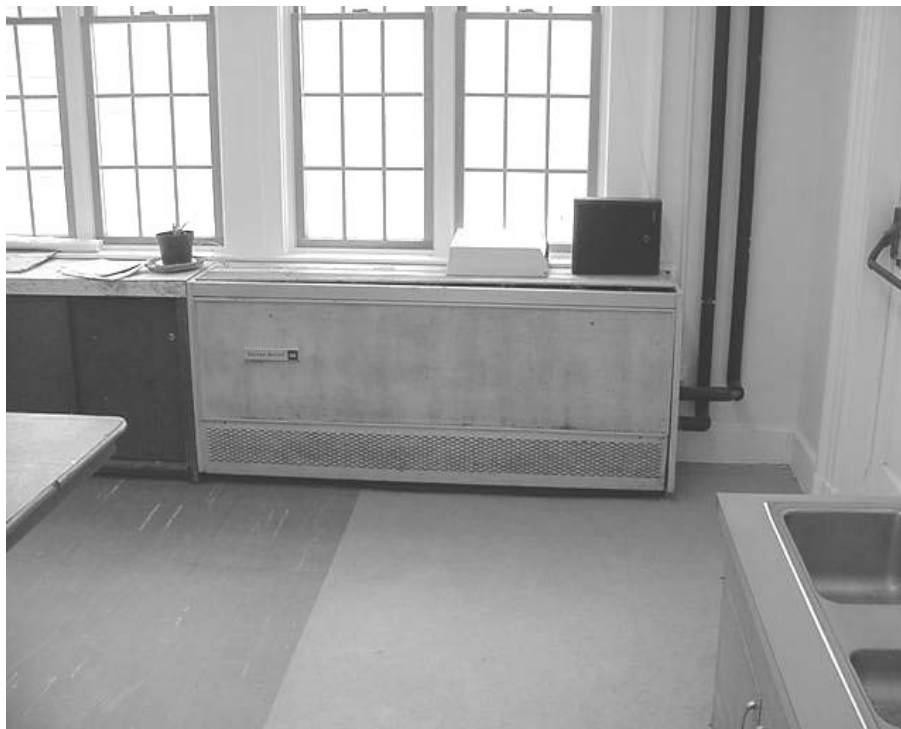
Picture 1

The upper floor does not have a mechanical ventilation system. Heat is provided by radiators. Ventilation is provided by opening windows. On the lower floor, mechanical ventilation was originally provided by a unit ventilator (univent) system (Picture 1). Univents draw air from outdoors through a fresh air intake located on the exterior wall of the building and return air through an air intake located at the base of the unit ([Figure 1](#)). Fresh and return air are mixed, filtered, heated and provided through an air diffuser located in the top of the unit. Univents were deactivated and appeared inoperable at the time of the assessment. MDPH staff examined the interior of the univent in the meeting room and found the fresh air intake blocked with newspaper (Pictures 2 and 2A). In this condition, the univent does not provide fresh air supply, but rather recirculates air only. In order for univents to provide fresh air as designed, intakes, air diffusers and return vents must remain free of obstructions. Importantly, these units must be activated and allowed to operate while rooms are occupied.

Univent

1. Examine the feasibility of installing a mechanical exhaust vent in the storeroom/water service room to remove odors and water vapor.
2. Consider should be given to replacing the univent and univent exhaust vent since repair of this equipment may be difficult due to its condition.

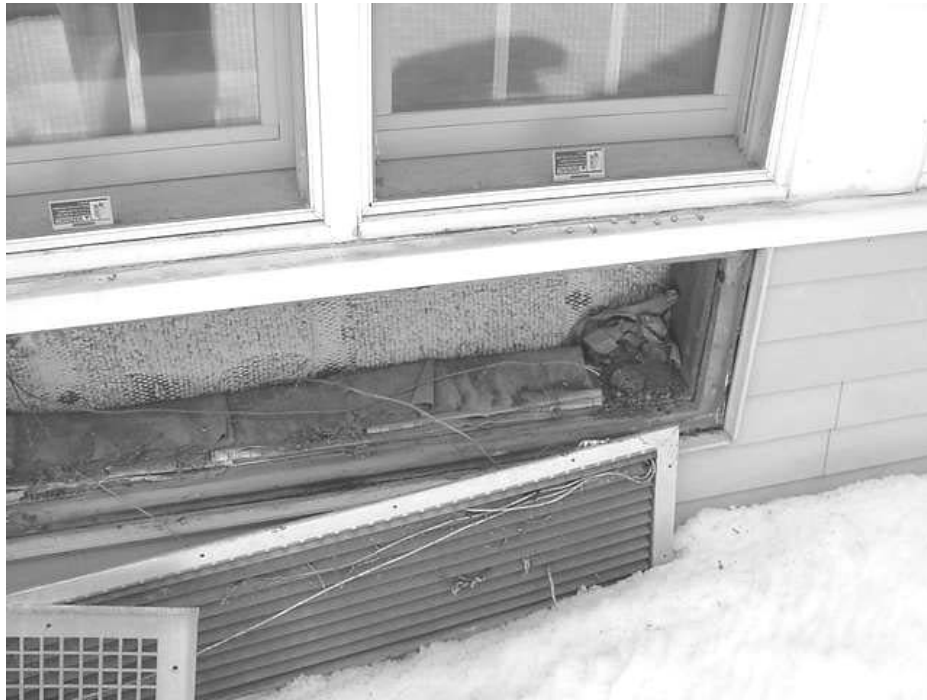
Picture 2

Fresh Air Intake for the Univent Was Blocked With Newspaper

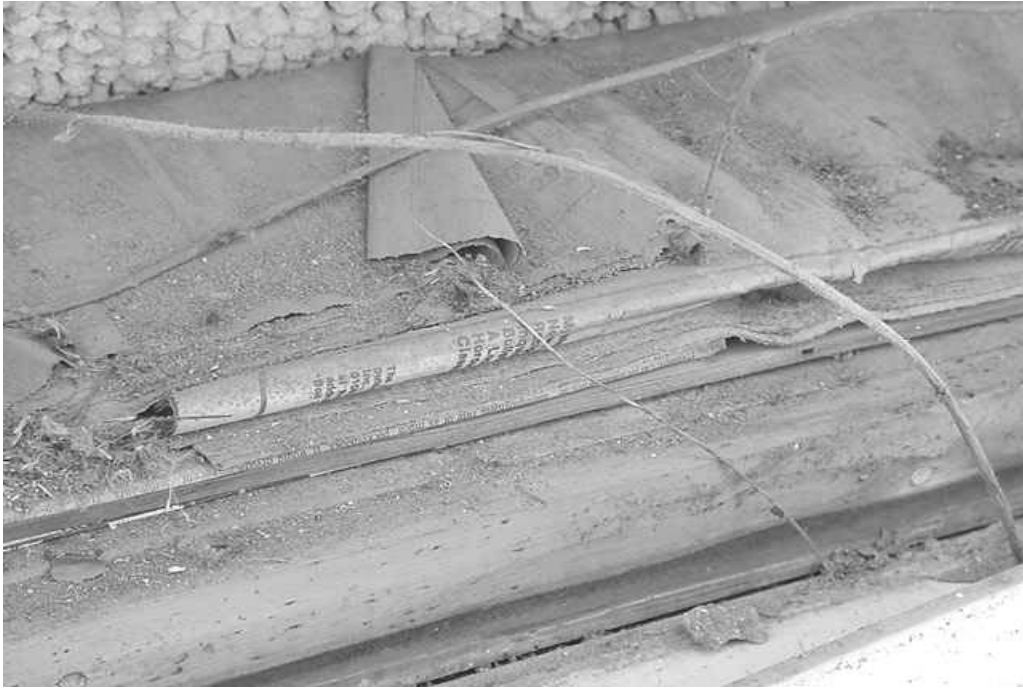
Picture 2A

Close-Up of Picture 2

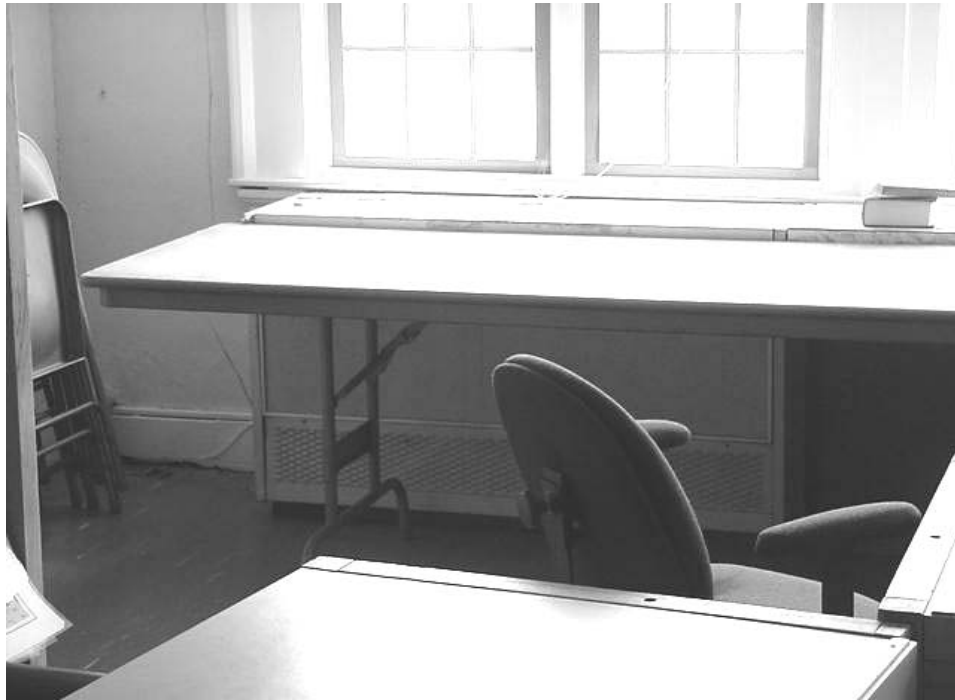
Picture 3

Exhaust ventilation on the lower floor is provided by unit exhaust vents (UEVs) (Picture 3). This equipment contains two fans that draw air from the building. The presence of rodent nesting materials inside the axial fan (Picture 4) of one of the UEVs

Unit Exhaust Vent (UEV), Behind Table (Note Air Intake Grill at Base of Cabinet)

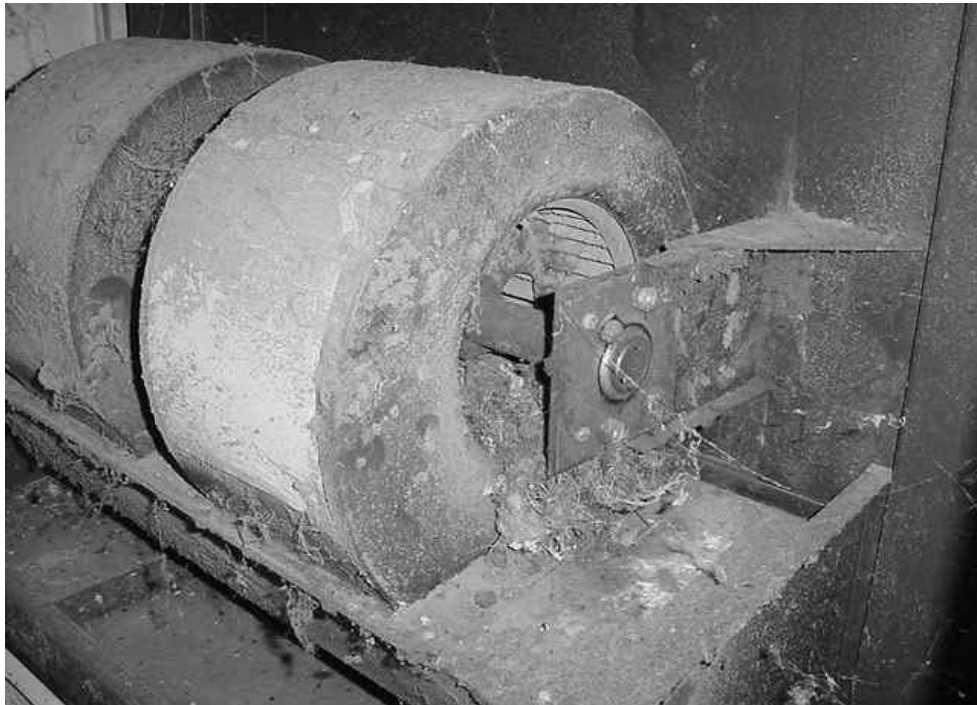
Picture 4

indicates that the UEV has not been used for some time. Without functional mechanical fresh air supply or exhaust ventilation, environmental pollutants can accumulate within the building and lead to air quality/comfort complaints.

According to town officials, the STH has a history of rodent problems, as was evidenced by nesting materials shown in Picture 4. Rodent infestation can result in indoor air quality related symptoms due to materials in their wastes. Mouse urine is known to contain a protein that is a known sensitizer (US EPA, 1992). A sensitizer is a

Rodent Nesting Materials inside the Axial Fan of UEV

- remove rodents;
- clean waste products from the interior of the building; and
- reduce/eliminate pathways/food sources that are attracting rodents.

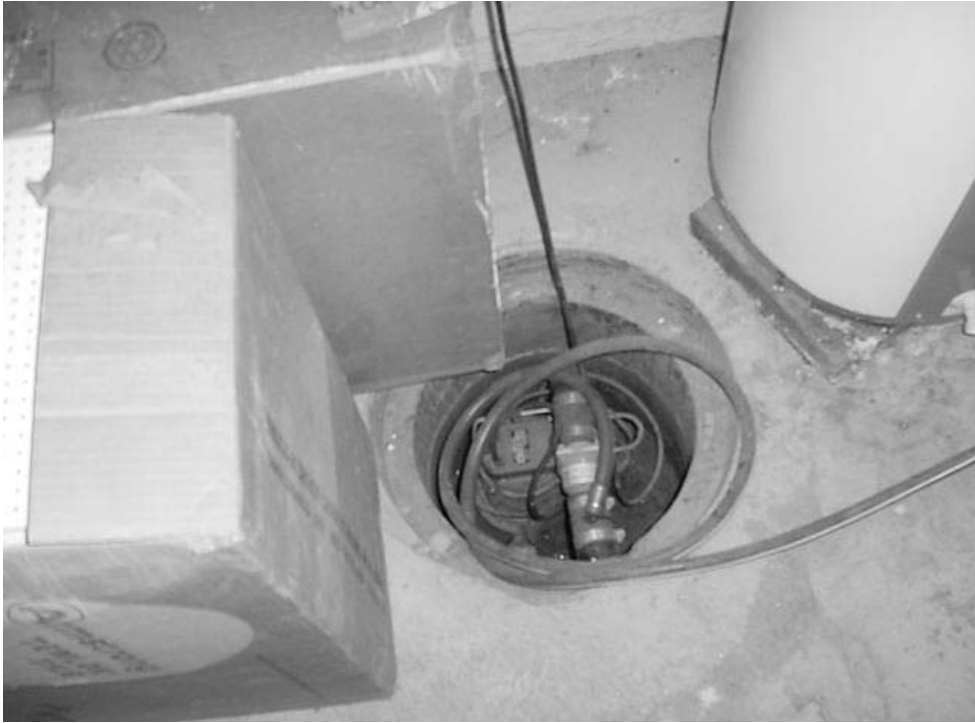
Picture 5

A distinct mold odor was detected along the north wall of the meeting room. The odor was traced to a wall vent which opens into a storeroom with a sump pump in its floor (Picture 5). A water tank and associated pipes are also located in a small room (the water service room), which shares a wall with the meeting room. The ceiling of the water service room has a manhole that leads outdoors. The water service room also contains a passive vent (Picture 6) that opens into the meeting room. The vent was covered by a wall hanging (Picture 7).

Storeroom Sump Pump, Note Cardboard Box over Pump

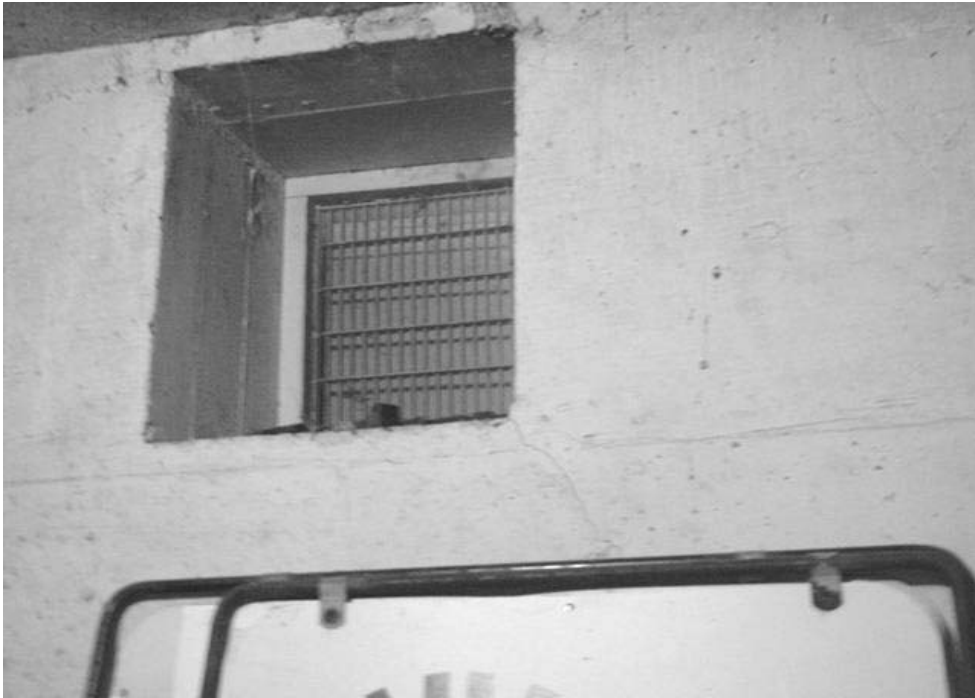
Picture 6

Water Service Room Passive Vent That was Covered by Bulletin Board

2. Seal the passive vents and the storeroom door with a temporary impermeable barrier (e.g., wood, gypsum wallboard). Ensure barrier is as airtight as possible by sealing edges and frames with polyethylene plastic and duct tape. Inspect for drafts and/or light penetration to ensure airtight integrity.

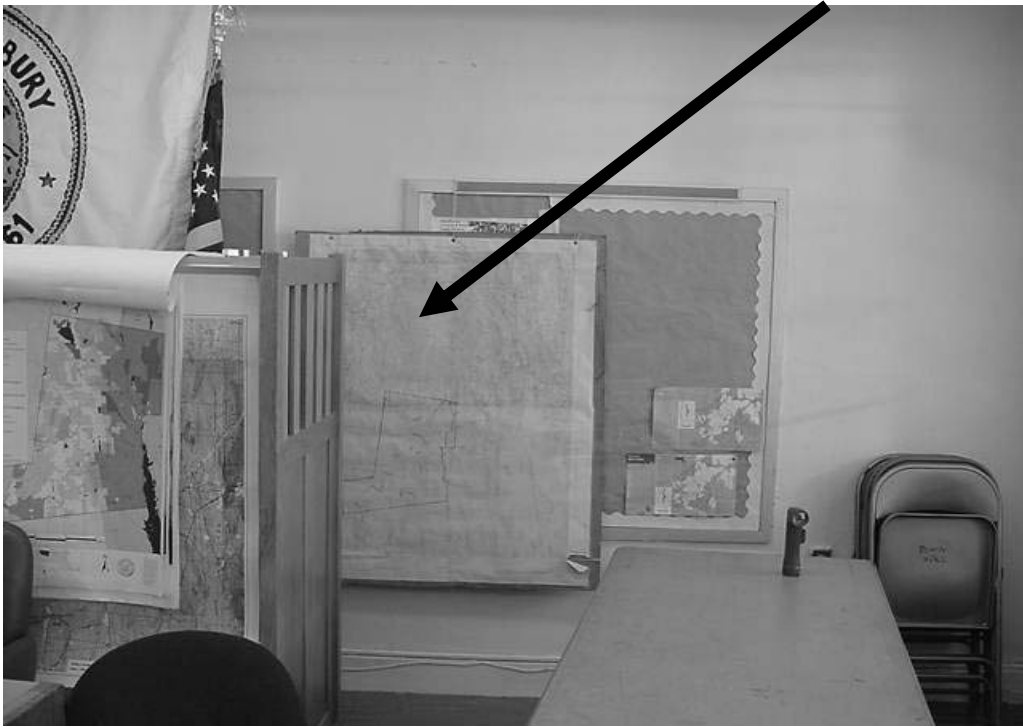
Picture 7

Approximate Location of Water Service Room Passive Vent

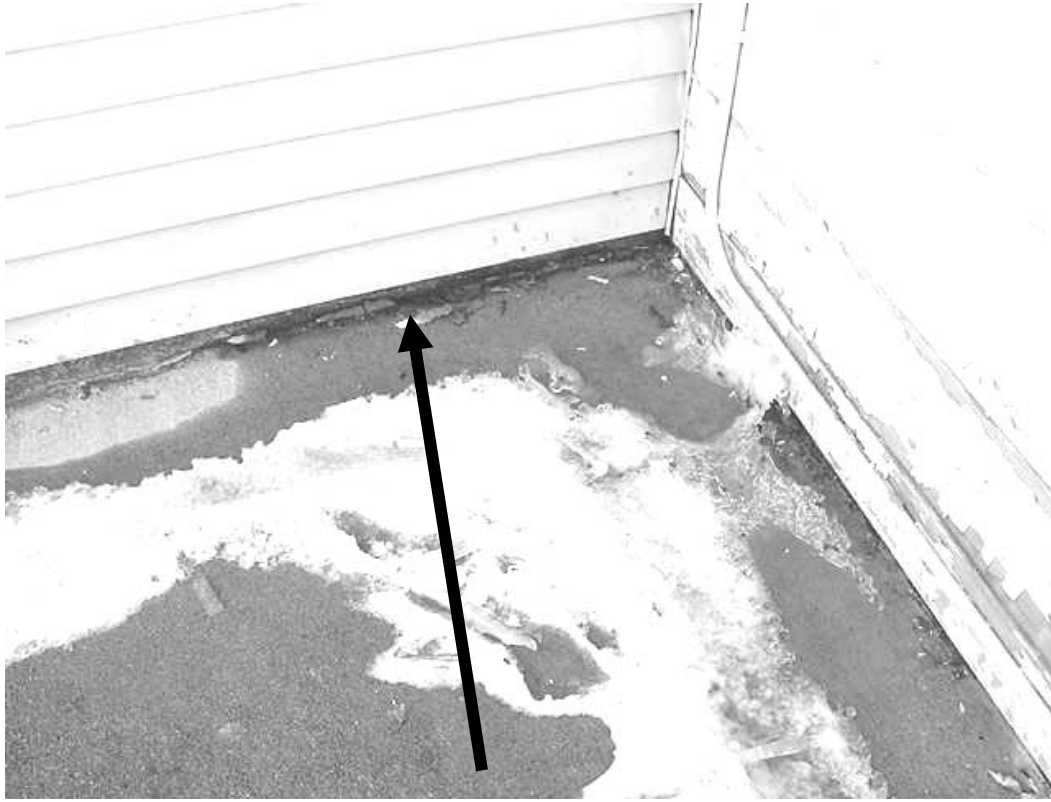
Picture 8

renovation, a cement walkway was installed along the front and eastern sides of the building. This walkway extends from the front door to a point roughly above the water service room. The sealant inserted into the seam between the foundation wall and walkway appears to be deteriorating (Picture 8). Missing/damaged sealant can allow moisture to penetrate into this crack and accumulate against the foundation wall, subsequently leading to moisture penetration into the storeroom. In addition the walkway is slanted to drain onto the bare soil above the water service room (Picture 9). Water damage and efflorescence was observed in the storeroom and water service room. Efflorescence is a characteristic sign of water damage to building materials such as brick or plaster, but it is not mold growth. As moisture penetrates and works its way through mortar and brick, water-soluble compounds dissolve, creating a solution. As the solution moves to the surface of the brick or mortar, water evaporates, leaving behind white, powdery mineral deposits. Conditions observed indicate that water has penetrated into the storeroom and water service room.

Damaged Sealant in Seam Foundation Wall/Walkway Seam, Northeast Section of Building

1. Since univents are inoperable, the sole source of fresh air is through windows. In order to temper room temperature and provide fresh air, the opening of windows is recommended. Use open windows and doors throughout the building to enhance airflow during warm weather. To aid in the draw of fresh outdoor air in warm weather, use portable fans directing air out windows on the leeward side of the building. Fans positioned in this manner will serve to increase the draw of outdoor air without interfering with the natural internal airflow pattern of the building.
2. Contact a ventilation engineer to examine the univent and unit exhaust vent to ascertain whether they are repairable. In addition, the ventilation engineer should confirm that fresh air intakes exist for the univents.
3. Replace the sealant in the walkway/foundation seam at the front of the building.

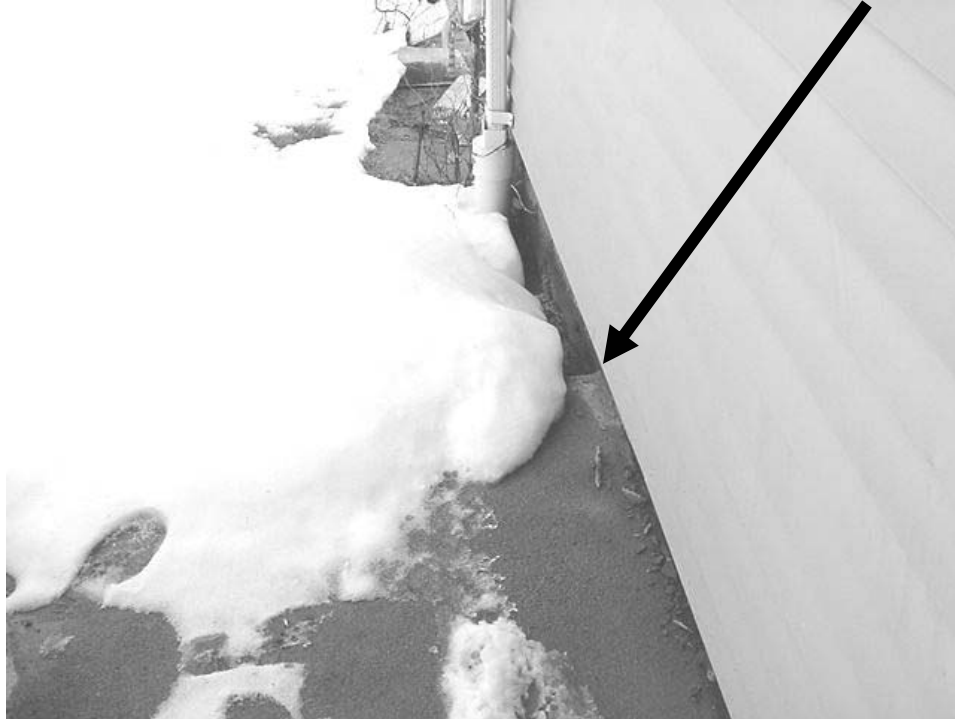
Picture 9

Moisture penetration through the storeroom wall is likely due to water accumulation against the foundation at the front (uphill side) of the building. As part of a

**End of Walkway, Note End of Cement Walkway with Snow on Soil against Foundation
(Northeast Section of Building)**

3. Consideration should be given to regarding the front of the building to enhance water flow away from the foundation. This may include either extending the walkway beyond the edge of the foundation or removal of the walkway. The following are general recommendations that could be used to improve drainage around the front of the building:

- a. Improve the grading of the ground away from the foundation at a rate of 6 inches per every 10 feet (Lstiburek & Brennan, 2001).
 - b. Install a water impermeable layer on ground surface (clay cap) to prevent water saturation of ground near foundation (Lstiburek & Brennan, 2001).

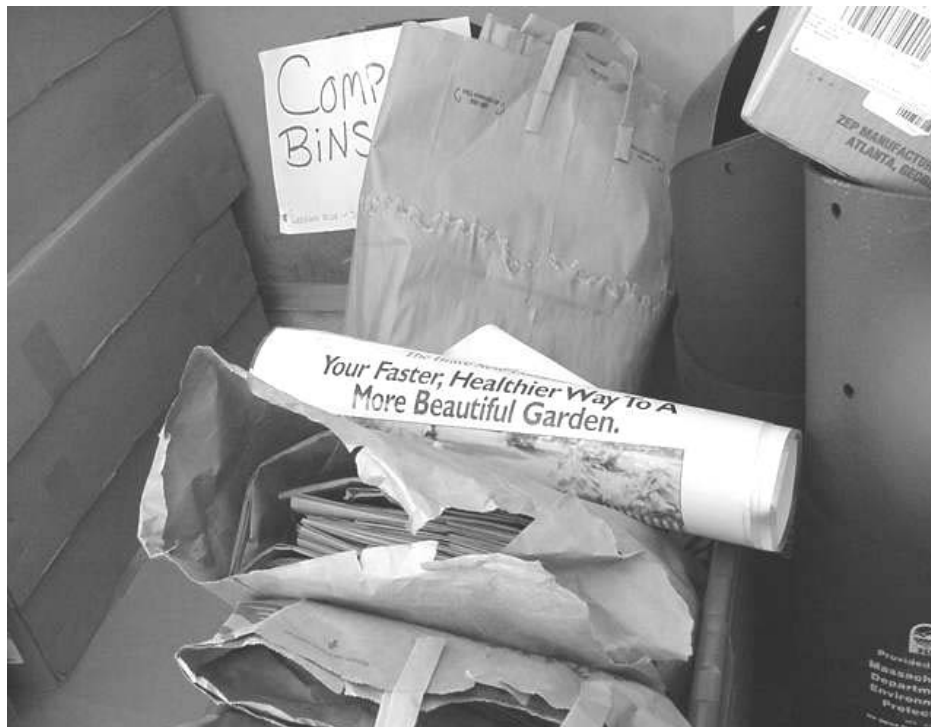
Picture 10

Water Damaged Materials in Senior Room

1. Discard stored materials and replace building materials that appear to have mold contamination. This measure will remove actively growing mold colonies that may be present. Remove mold contaminated materials in a manner consistent with recommendations in “Mold Remediation in Schools and Commercial Buildings” published by the US Environmental Protection Agency (US EPA,

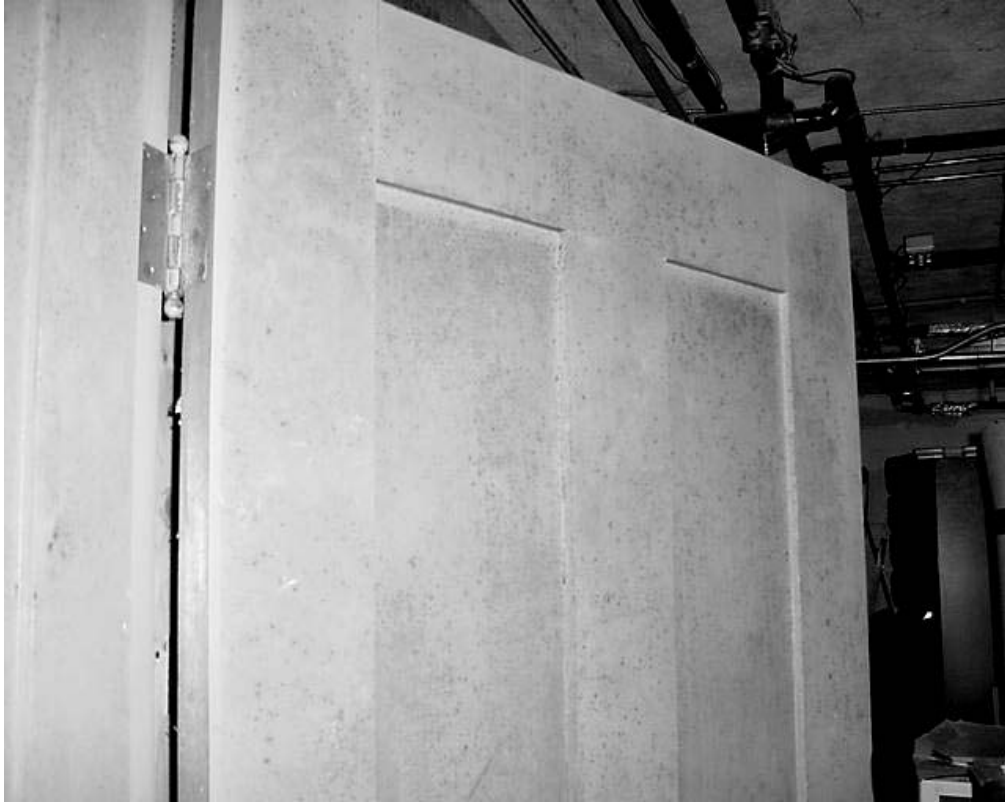
Picture 11

Water Service Room Door with Mold Colonies

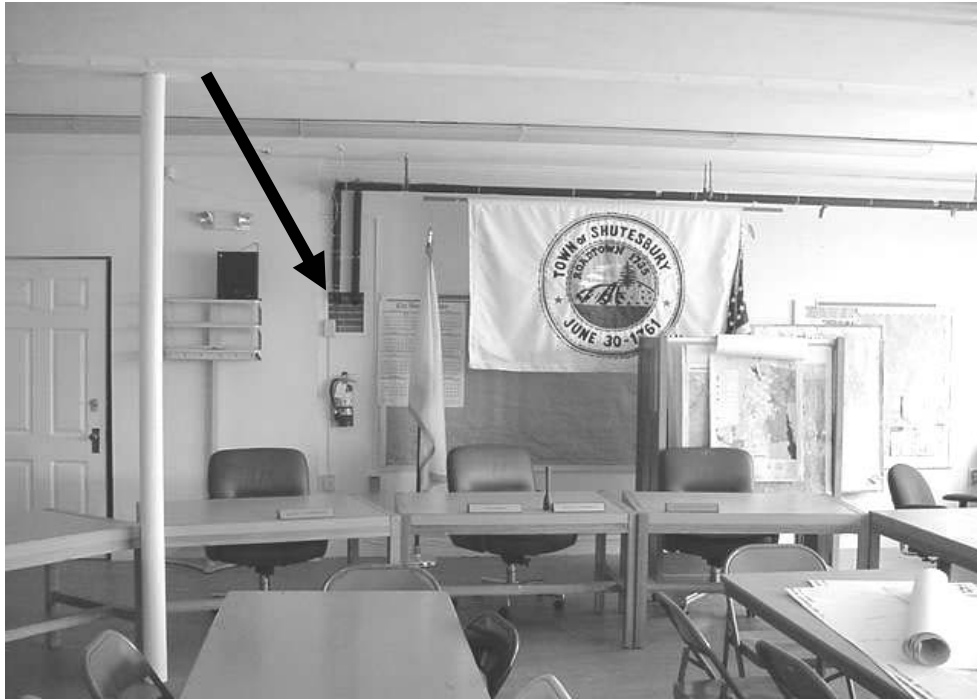
Picture 12

The passive vents to the storeroom and water service room that open to the meeting room and senior room (Pictures 12 and 13) serve as pathways for odors and other mold related particulates to migrate into occupied areas. Typically, passive air vents are used to provide make-up air for a mechanical exhaust vent. No mechanical exhaust vents could be identified in this area by MDPH staff. A mechanical vent of this nature would likely have to operate continuously to remove storeroom odors and more importantly, water vapor that can moisten materials.

Passive Vent in Meeting Room

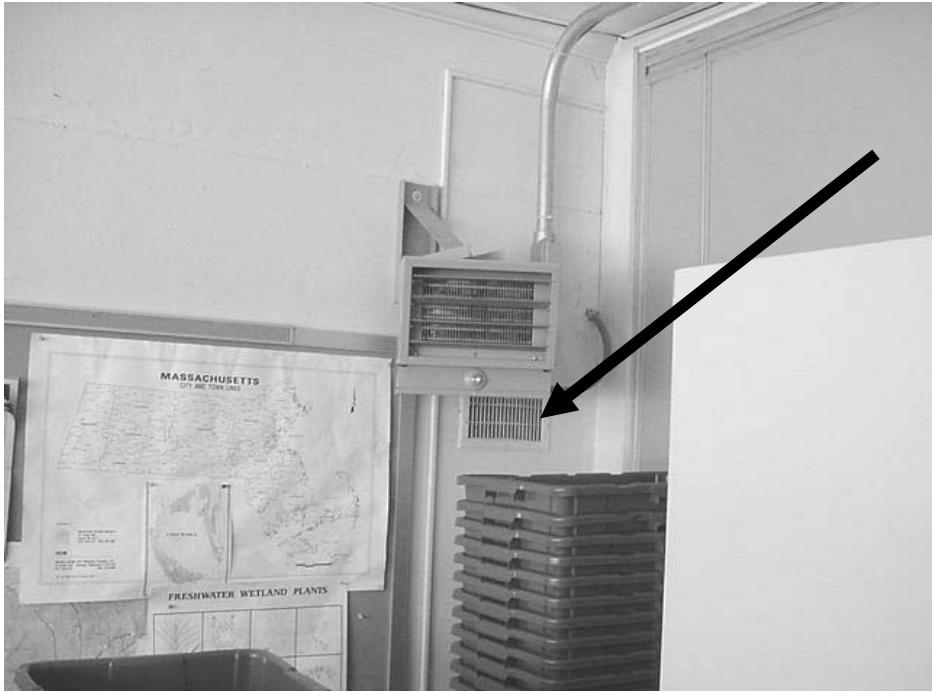
Picture 13

Passive Vent in Senior Room

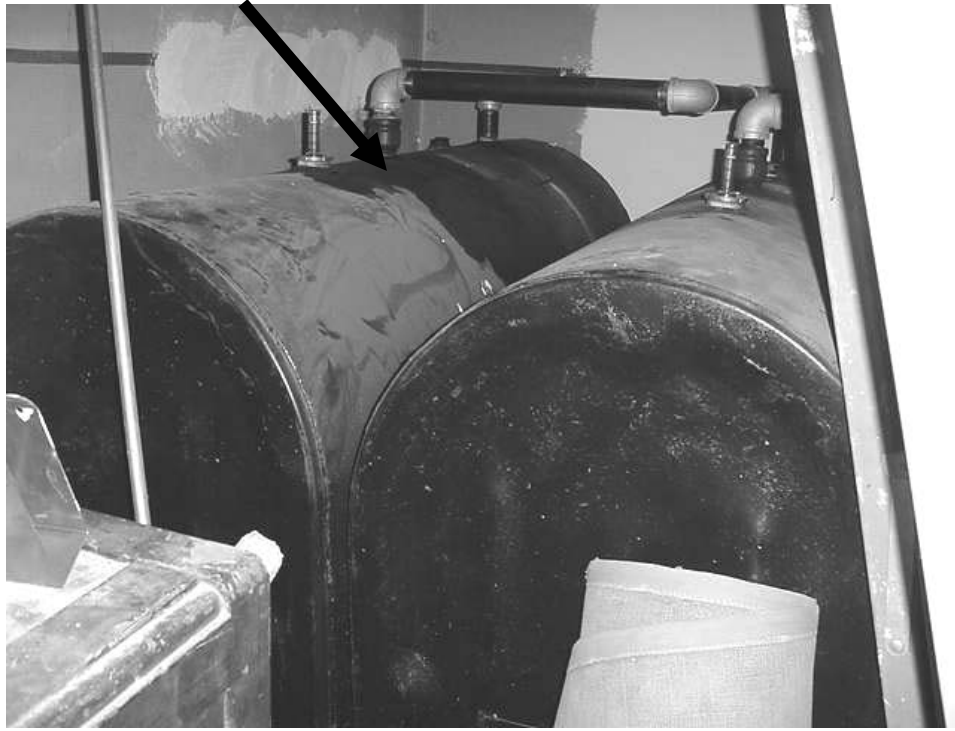
Picture 14

Several other conditions that can potentially affect indoor air quality were identified during the assessment. A distinct fuel oil odor was noted at the base of the stairs in the lower level. The odor was traced to the furnace room opposite the stairwell. Inside the furnace room are two tanks that were coated with oil from overfill (Picture 14). An absorbent material used to soak up oil was also observed beneath the furnace oil pump (Picture 15).

Oil Coated Tanks

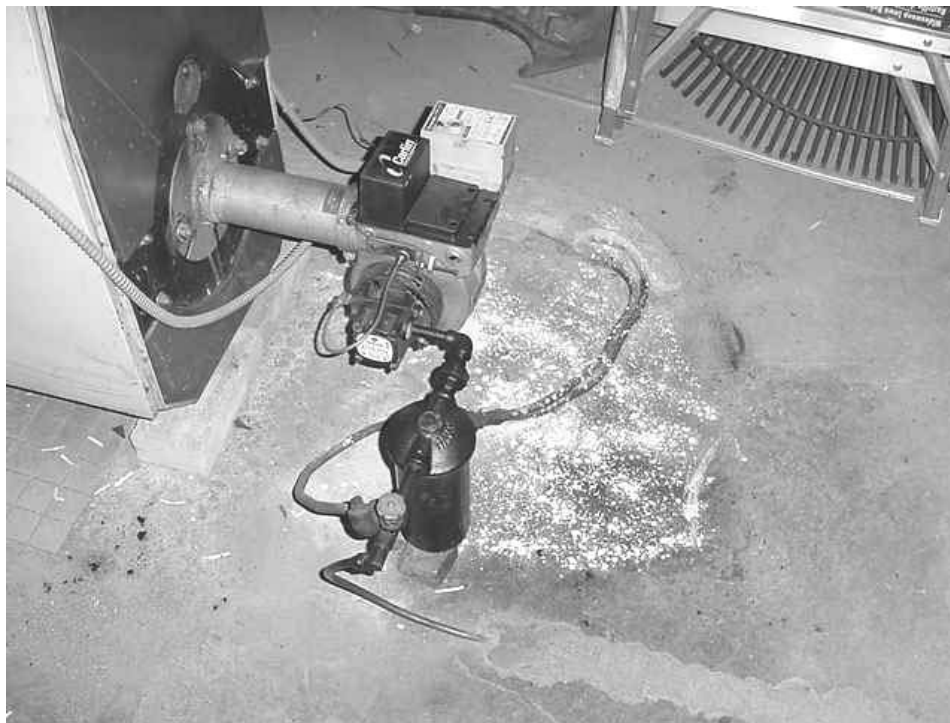
Picture 15

Absorbent Material beneath Furnace Oil Pump

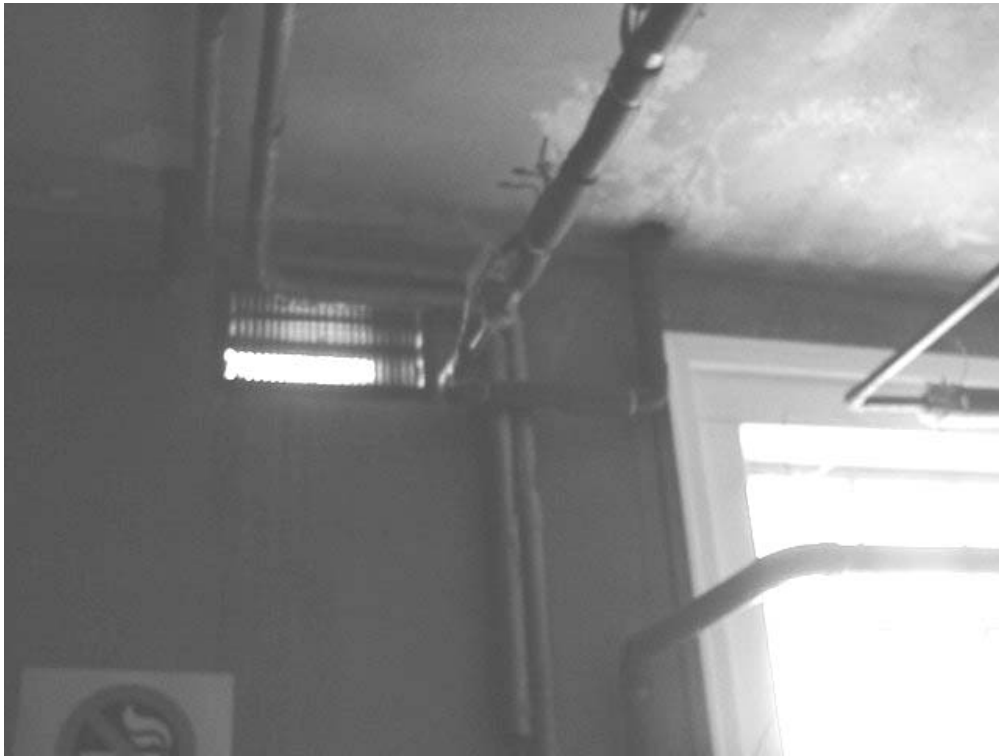
Picture 16

Of note was a steady stream of cold, outdoor air from a vent (Picture 16) located in the exterior wall. The vent is located in the southwestern corner of the building. The prevailing winds in Massachusetts tend to be from the west (Trewartha, 1943). In this configuration the prevailing winds would impinge on the vent on a regular basis. Air forced into the vent under windy conditions will pressurize the furnace room, which would in turn force air and other odors within the furnace room into the lower level corridor through spaces around the furnace room door. The purpose of the open vent was unclear since another ducted vent system also exists in the room that appears to provide combustion air for the furnace (Picture 17). Cold air was detected flowing from the ducted system. Combustion air is necessary for a furnace to burn fuel. Frequently an open passive vent connected to a duct with multiple turns is used to provide oxygen for the furnace while preventing/limiting pressurization of the furnace room under windy

conditions. A furnace room should be either neutral pressure or depressurized as air is draw into and consumed during the combustion process.

Open Vent in Furnace Room

1. Examine the vented duct for adequate combustion airflow for the furnace.
2. When adequate combustion airflow from the ducted vent is established/confirmed, seal the second vent.
3. Clean oil residue from tanks and floor.
4. Render the furnace room door as airtight as possible by installing weather-stripping on the doorframe and a door sweep at the bottom of the door. Seal seams in the wall and doorframe with an appropriate, fire-rated sealant.

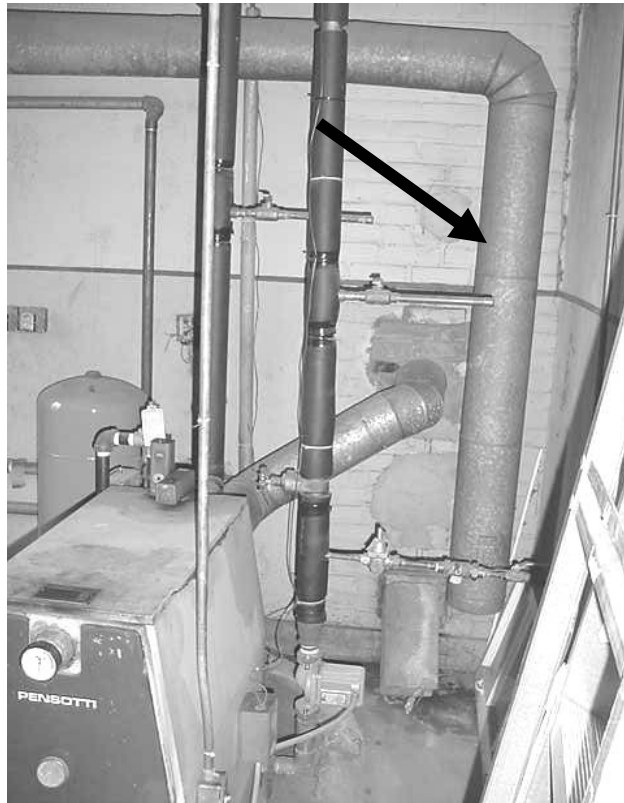
Picture 17

Duct for Combustion Air in Furnace Room

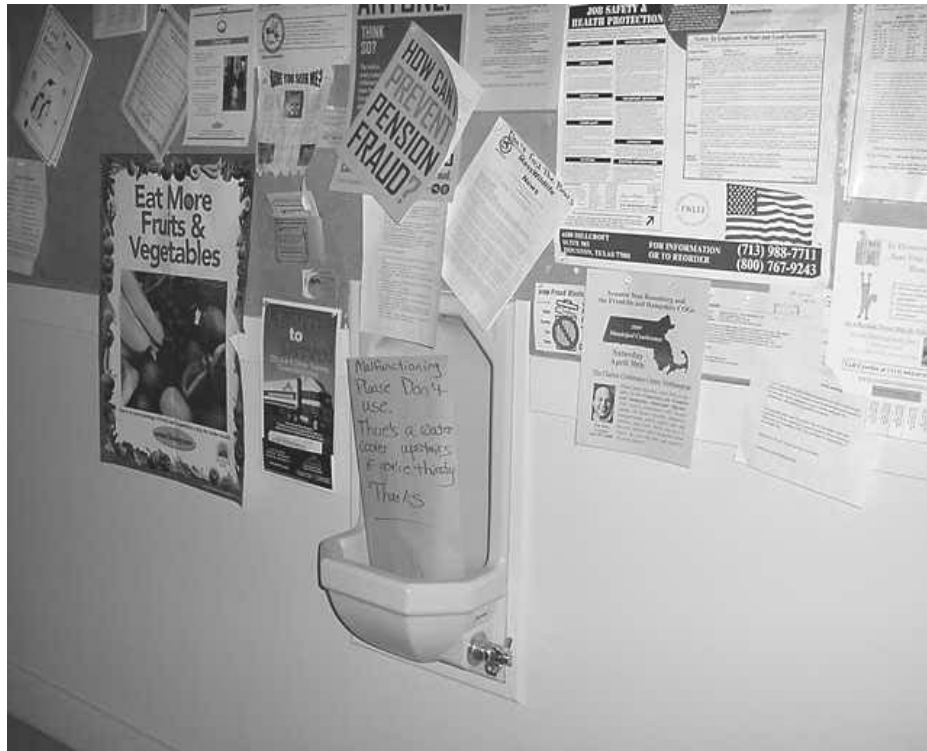
Picture 18

Finally, the basement has an abandoned water bubbler (Picture 18). It appeared that no water had been poured into these drains recently. Without water, the drain traps can dry, resulting in the loss of the airtight seal created by a wet trap. A dry trap can result in sewer gas backing up into the building under certain circumstances. Sewer gas can be irritating to the eyes, nose and throat.

Abandoned Water Bubbler

4. Refrain from storing paper, cardboard or other porous materials in the storeroom until water penetration through the foundation is resolved.
5. Seal abandoned/unused water bubbler drains. Be sure to also shut off the water supply to prevent accidental flooding.
